## Performance of Sidr affected a Few Typical Non-engineered Buildings at the Ganges Delta

### **Summary**

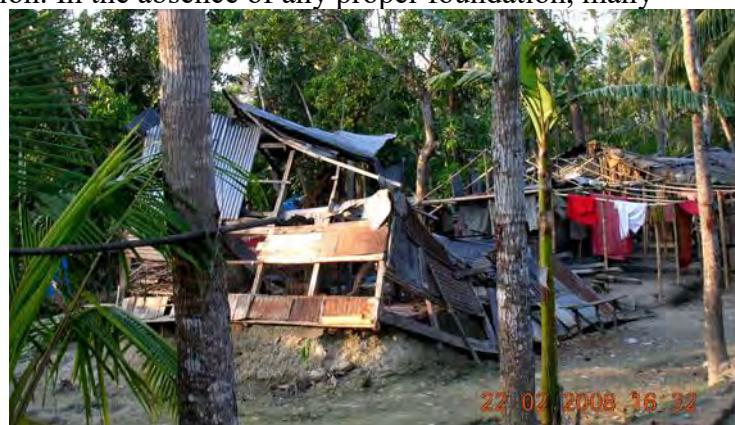
The study of the damage profile suggests that one of the primary reasons behind the various types of failures of the surveyed non-engineered buildings is weakness at the junctions of different structural elements. Failures of roof cladding materials of different structures were surveyed to be the commonest area of damage due to cyclones. The causes are usually inappropriate fastening devices, inadequate thickness of the cladding materials and insufficient frequencies of fasteners in the known areas of greater wind suction. It was observed that many-a-time, the wooden beams and the wooden columns were anchored with each other through a single nail or at the most through a single bolt. At the time of withstanding the lateral thrust of the Sidr, these junctions have acted as hinges, which allowed rotation of the members around the junctions and resulted into consequent damages. Further, a close inspection of the local building-construction practice revealed the fact that wooden / bamboo columns are simply placed over tiles or blocks of masonry without any attachment or anchorage in lieu of foundation. In the absence of any proper foundation, many building structures suffered overturning and / or dragging on the plinth. Figure 1 is a representative illustration of total devastation portraying the various types of damage profiles discussed above.

*Fig 1: Totally devastated Residential Building at the Nalchhity Municipality, Jhalakathi District, Bangladesh*
